30 Hong Kong landslides

STEPHEN R. HENCHER AND ANDREW W. MALONE

ABSTRACT

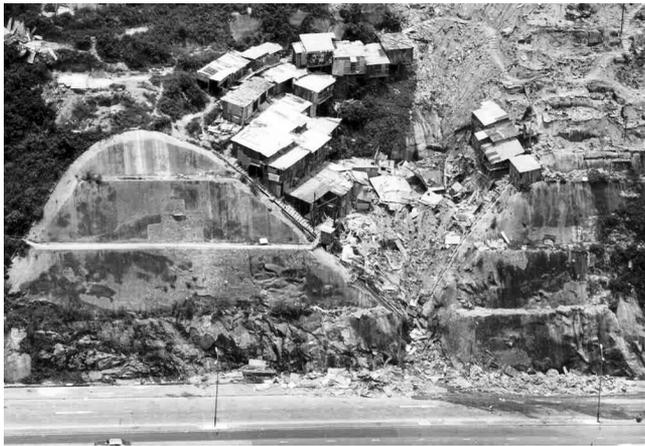
Fig. 30.1. Failure involving squatter huts at Yuen Mo Village, Lam Tin, 1982.

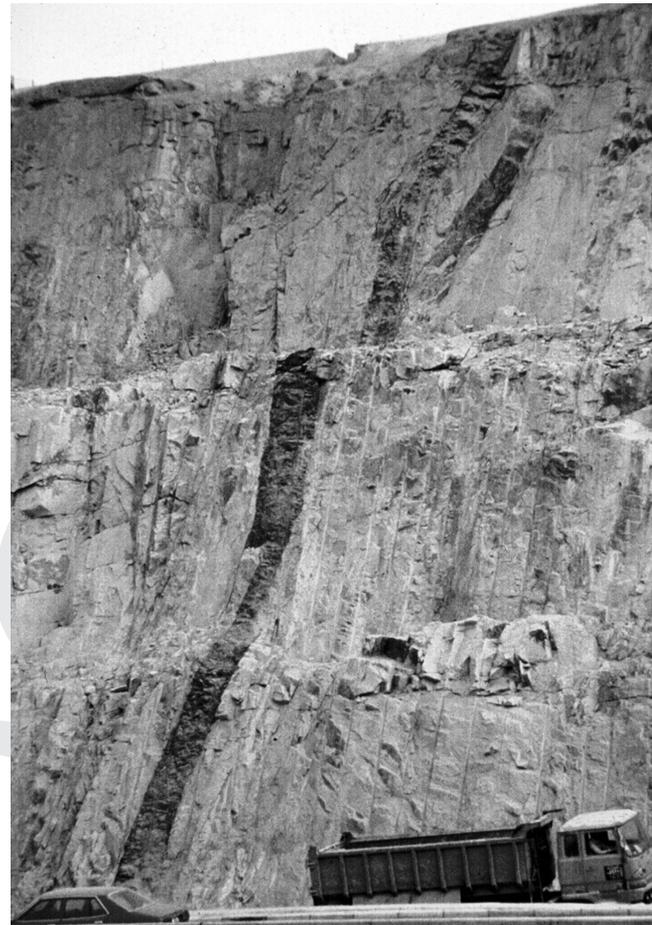
Fig. 30.3. Mafic dike cutting granite.

Mafic and intermediate dikes cut the major volcanic and granitic bodies (Fig. 30.3). Where fresh, the contacts tend to be sharp and fused, but where weathered, grain-size contrasts between the intrusion and host rock result in abrupt changes in permeability.

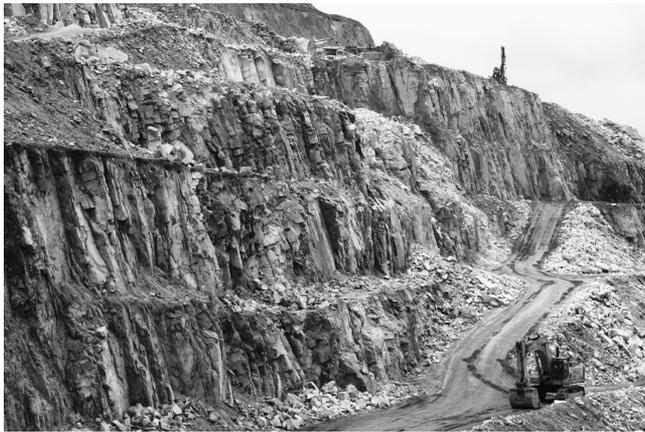
Fig. 30.5. Closely jointed granite, Anderson Road Quarry.

1997). Toward the center of the granitic plutons, where encountered at depth in tunnels, visible joints may be extremely widely spaced (tens of meters), but nearer the ground surface the rock tends to be more extensively jointed (Fig. 30.5). It is evident that many of these visible fractures have opened up through weathering and exhumation, as discussed by Hencher and Knipe (2007). The process is illustrated by the comprehensive disintegration into small fragments of a rock wedge defined by master joints in moderately weathered rock in Figure 30.6a, b. Within the granitic rocks, especially, joints tend to be steeply dipping and occur in orthogonal sets. Shallowly dipping joints also occur, and some of these are probably formed by shrinkage during cooling (Table 30.1). Sheeting joints are common in Hong Kong and occur as extensive features running roughly parallel to the steep terrain in rock that was unfractured at the time of slope formation (Hencher *et al.*, 2011). They are characteristic of many exposed, weakly weathered, granitic bodies, but are less common in volcanic terrain, probably because these rocks contain relatively close incipient jointing that allows stresses to be dissipated without the formation of new fractures. Sheeting joints are commonly associated with rockfalls and deeper-seated failures, especially where the joint walls are severely weathered or where the joints persist as relict discontinuities within a thick weathering profile. Such joints are commonly associated with channelized water flow, development of cleft and perched water pressures, and the influx and deposition of transported soil.

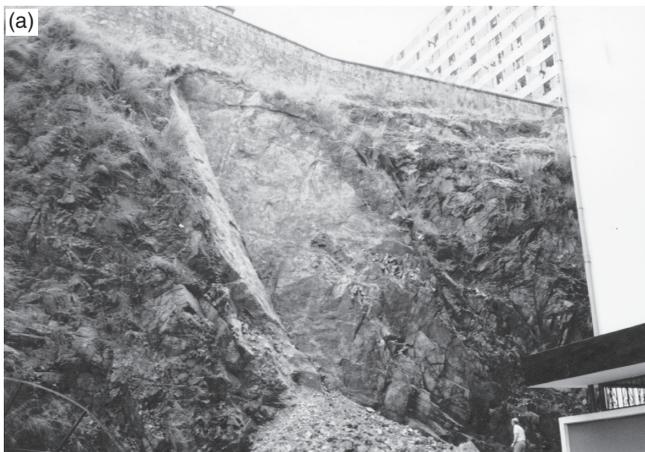
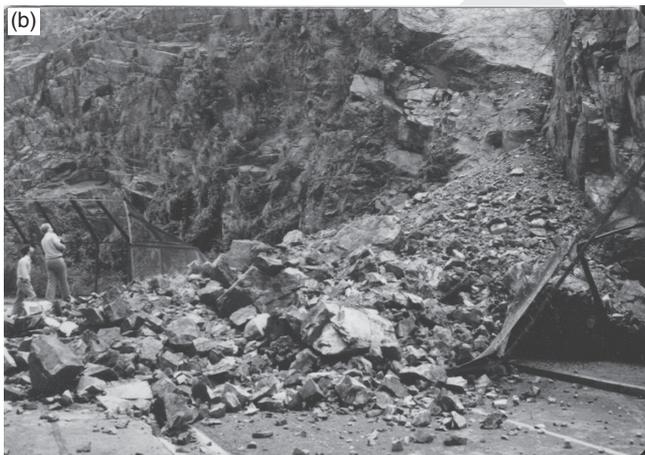
Fig. 30.6. (a) Well-defined wedge failure along master joints in volcanic rock, Kwai Shing Estate, Tsuen Wan. b) A wedge that has broken up along closely spaced incipient joints.

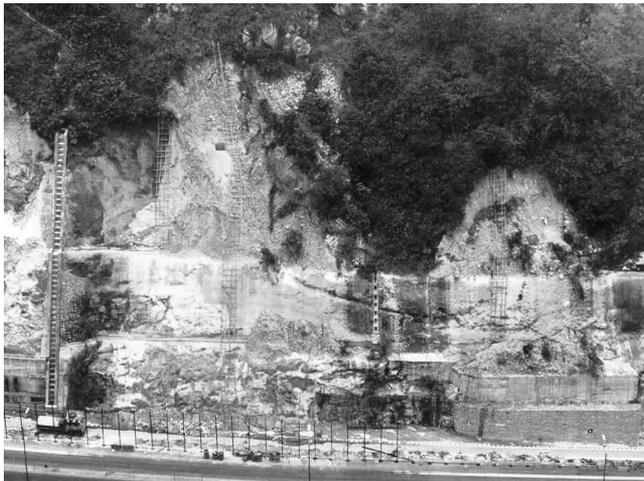
Fig. 30.11. Slope failures on Tuen Mun Highway; a shallow-dipping dike runs up through main landslide.

Figure 30.11 shows a series of Type IIa landslides on the Tuen Mun Highway in Hong Kong. Martin and Hencher (1984) attributed the largest failure to temporary perching of water above a weathered dike, which is seen as a depression in the slope below. The weathered dike is less permeable than the granite. Several other examples are presented in Hencher *et al.* (1984) and in Hencher and Lee (2010).
